Manhole Inspection Summary

Manhole # S71O__003MH

Location Address: **1300 Bethlehem Ave.**

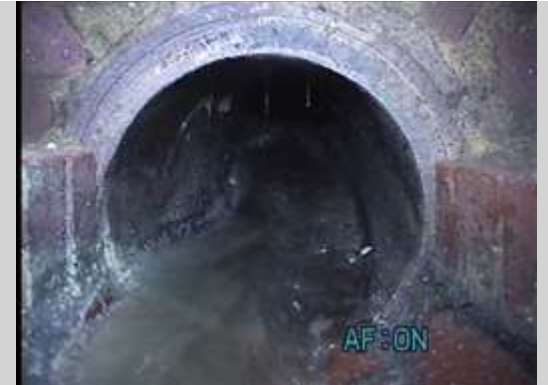
12 O'Clock Outflow

12 in. Circular Gravity Sewer
Pipe Out @ 12 O'Clock

Pipe Height: **12** (in.) Rod and Bar (Angled)
Pipe Material: **Clay** ☐ Pipe Lined
Invert Depth: **11.58** (ft.) Flow Characteristics: **Fast**
Deposits: ☒ None ☐ Mud ☐ Sludge ☐ Debris ☐ Grease
Silt Depth: (in.) Deposits Extent:
Infiltration: **None** Pipe Seal Cond: **Sound**

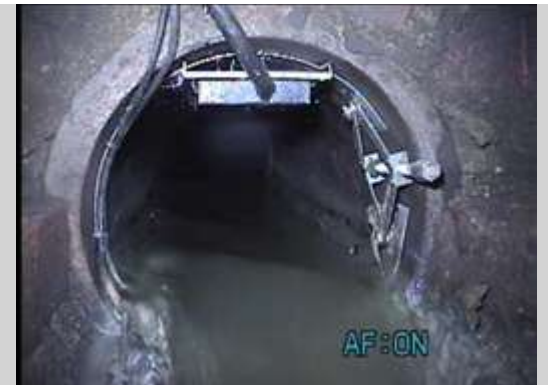
5 O'Clock Inflow

10 in. Circular Gravity Sewer
Pipe In @ 5 O'Clock

Pipe Height: **10.8** (in.) Rod and Bar (Angled)
Pipe Material: **Clay** ☐ Pipe Lined
Invert Depth: **11.25** (ft.) Flow Characteristics: **Fast**
Deposits: ☒ None ☐ Mud ☐ Sludge ☐ Debris ☐ Grease
Silt Depth: (in.) Deposits Extent:
Infiltration: **None** Pipe Seal Cond: **Sound**
